# Evaluating Levittown Pennsylvania Homes for Energy Savings – Part 1

*A Case Study in evaluating the potential for energy conservation  
in existing tract housing developments.*

Kevin J. Deeny, P.E.

KC Environmental, Inc.

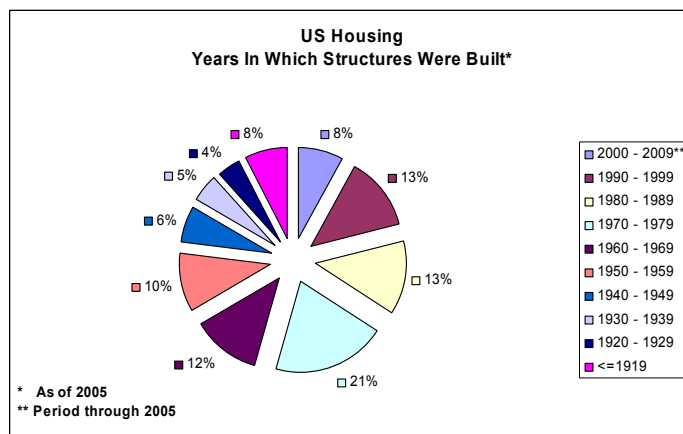
Figure 1: Age distribution of housing in the US.<sup>5</sup>

Much of the nation's housing was built at a time when energy resources were cheap and plentiful. Figure 1 illustrates the estimated distribution of housing in the US according to the year it was built. The vintage distribution indicates that almost 1/3<sup>rd</sup> of US housing

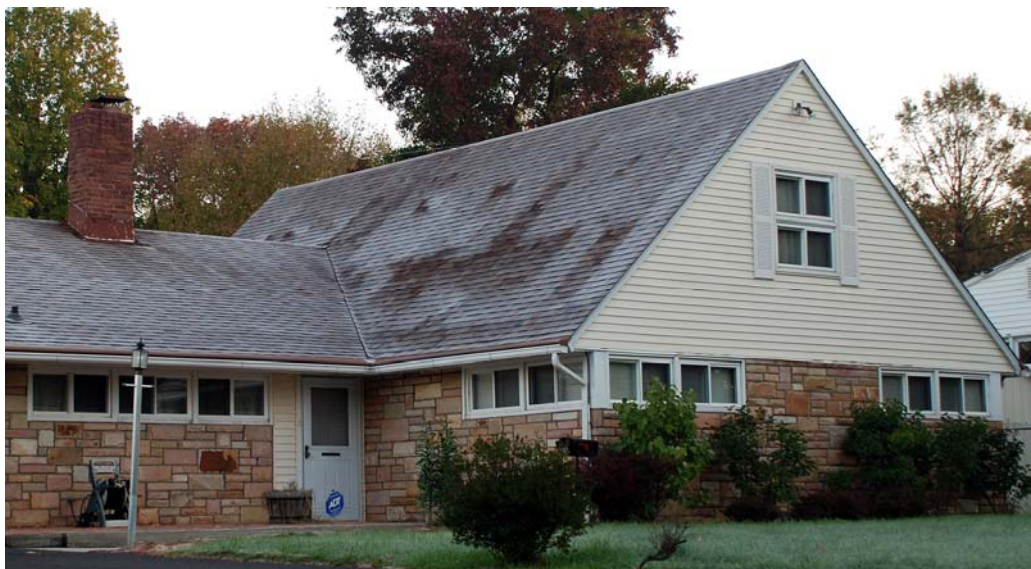
**Figure 9: Photo of Levittown roof with heat loss patterns.**

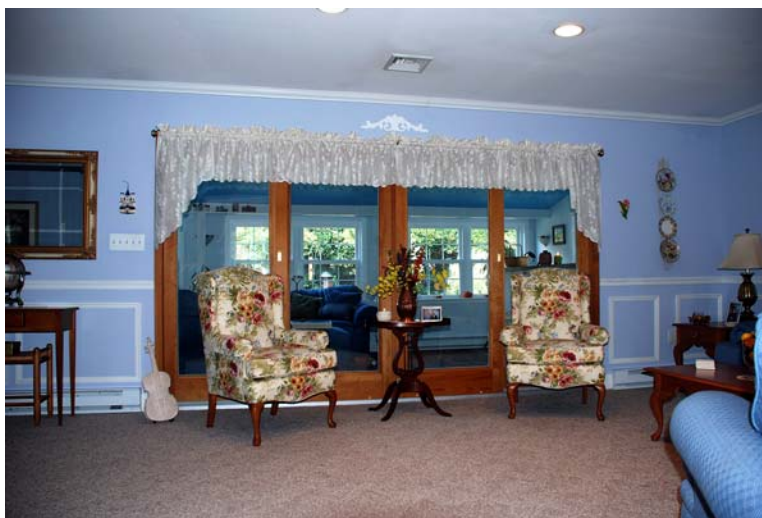
**Figure 12: Country Clubber with Energy Star rated replacement patio doors.**

Replacement of the patio doors can also dramatically reduce heat loss and improve the comfort level of the home. They enhance the beauty of the room and bring light into the home. See Figure 12. Words of caution for home owners contemplating a DIY approach – these doors are very heavy and assistance is necessary to remove and replace these units.

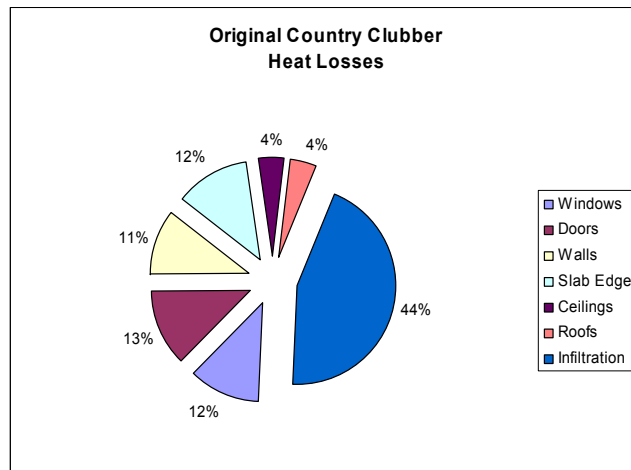
**Figure 13: Distribution of heat losses from an original Country Clubber model.**

The total heat loss for the home is estimated to be nearly 59,400 BTU/hr. Figure 13 shown below illustrates the heat loss distribution graphically. As indicated, this estimate is dominated by infiltration losses that account for 44% of the heat loss from the home. Nearly half of this heat loss is attributed to the fireplace. It is noteworthy that the glass patio doors emit more heat than all of the windows combined and the concrete slab emits more heat than all of the walls combined. Although the estimates indicate relatively high losses from the home much of the loss is in areas that are subject to control by homeowners.
